Sustainable Heritage Buildings: The Impact on Heritage Values, Energy Performance, and CO₂ Emissions

Abstract

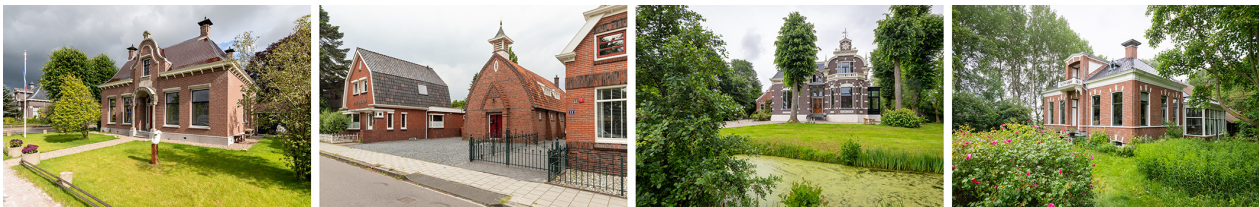
Figure 1. The case study buildings: Leens, Musselkanaal, Appingedam, and Spijk (Mark Sekuur, 2024).

Our case study buildings were part of a subsidy program in the province of Groningen: Major Maintenance, including Restoration of National Listed Buildings Groningen (*Groot onderhoud waaronder Restauratie Rijksmonumenten Groningen*; Provincie Groningen, 2024). An advantage of selecting case studies from this subsidy program was the availability of comprehensive project documentation. The province contacted subsidy recipients, and six building owners responded positively. Preference was given to buildings where the owner was actively involved in daily operation. As a result, one case was excluded because the owner leased the property to a commercial tenant. The remaining five buildings are privately owned and used as residences. In this article, only four case studies (Figure 1) are presented due to insufficient data for one project.

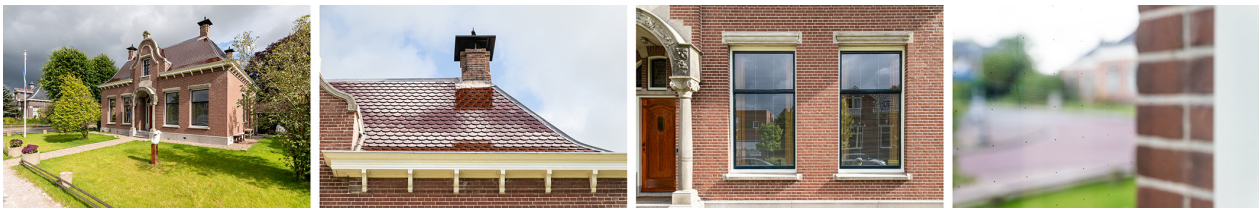
Figure 2. Case in Leens after the construction process (Mark Sekuur, 2024).

- Exterior walls: Maintenance and applying cavity wall PIR granulate insulation;
- Windows: Replaced the single glazing with vacuum glass;
- Roof: Fully replacing the broken roof tiles and applying glass wool insulation;
- Modernisation: New bathroom and kitchen;

A photo impression of the building after renovation is presented in Figure 2.

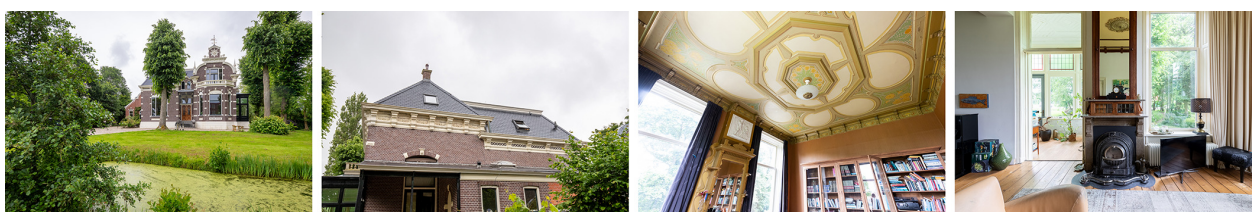
Figure 4. Case in Appingedam after the construction process (Mark Sekuur, 2024).

A photo impression of the building after renovation is presented in Figure 4.
